# PRODUCTION ENGINEERING ARCHIVES

## The influence of the damaged reinforcing bars on the stress-strain state of the reinforced concrete beams

The article is devoted to the overall view of experimental research of reinforced concrete beams with the simultaneous influence of the corrosion environment and loading. The tests have been carried out upon the reinforced concrete specimens considering the corrosion in the acid environment, namely 10 % H<sub>2</sub>SO<sub>4</sub> that have been taken as a model of the aggressive environment. The beams are with span equalling to 1,9m with different series of tensile armature, concrete compressive strength and different length of impact of corrosion (continuous and local). The influence of simultaneous action of the aggressive environment and loading on strength of reinforced-concrete beams has been described. For a detailed study of the effect of individual components there was suggested additional experimental modelling of the only tensile armature damage without concrete damage. It will investigate the influence of this factor irrespective of the concrete.

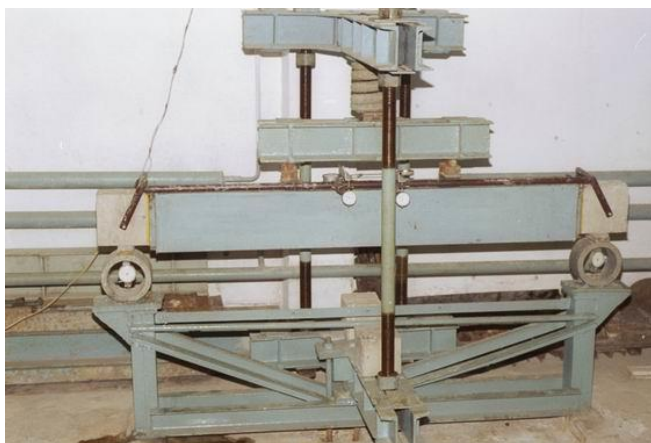
**Fig. 1.** The overall view of the beam during testing  
Sources: (KHMIL R.Y. 2003)

facts, experimental researches was carried out within the laboratory work with the general amount of 22 reinforced concrete beams which were under the simultaneous influence of loading and aggressive environment (KHMIL R.Y. 2003, VASHKEVYCH R.V. 2005). Reinforced concrete beams were under the loading 0,3; 0,5; 0,7 from the limit load which corresponded to the maximal bearing capacity of beams. 10% sulfuric acid solution ( $H_2SO_4$ ) has been used as an aggressive environment which has been placed in special containers of attached above beams. The loading has been applied in the third part of the beams' span in the form of two focused forces (Fig. 1, 2).

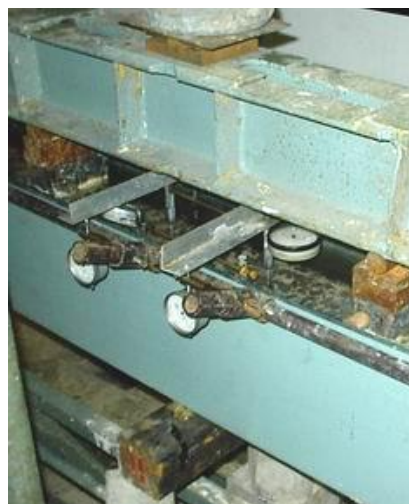
**Fig. 3.** Gauges position on of the beam during testing.

The deformations of concrete, armature and beams' deflections have been measured by gauges (Fig. 3).

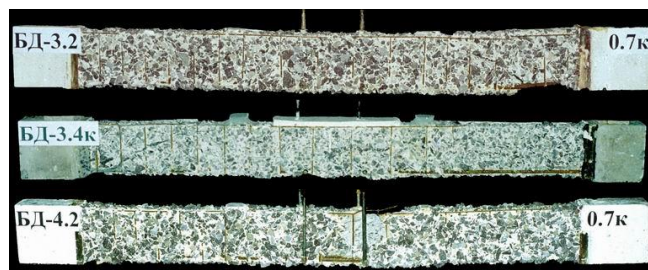
**Fig. 4.** The overall view of the beam after testing  
(KHMIL R.Y. 2003)

The overall view same specimens after testing are presented on Fig. 4, 5.

The analysis of the results of the experimental research shows that owing to the influence of the aggressive environment the concrete and armature received significant corrosion damages. As a result of obtained damages of concrete a reduction of the cross section occurred. Moreover, the increase of the concrete, armature and bends' deformations was witnessed. It is worth noticing that in beams, where the concrete damage did not cause a full destruction of the armature protective layer, its corrosion was not been observed. In beams where the protective concrete layer was destroyed the corrosion of the tensile armature as well as the reduction of

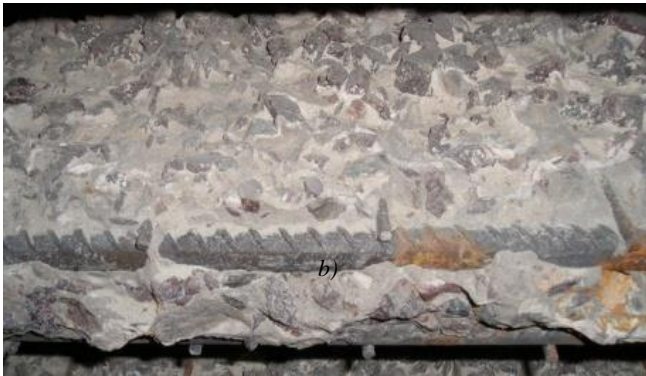
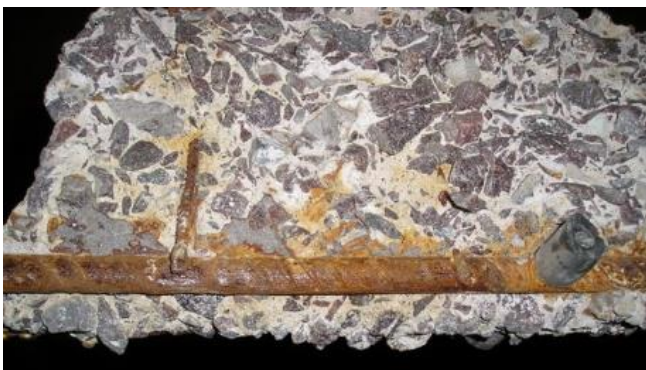
**Fig. 6.** The overall view of the armature corrosion:

a) a small corrosion intensity; b) a bigger corrosion intensity

its cross section was observed. This was accompanied by a significant increase of the beams' concrete and armature deformation and finally led to the exhaustion of their bearing capacity. Additionally, it is worth mentioning that the armature corrosion took place unequally (not simultaneously) along the perimeter – only from the side of the destroyed protective layer. From the inner side owing to the dense attachment of concrete the corrosion of armature did not take place (Fig. 6).
