# PRODUCTION ENGINEERING ARCHIVES

## Vibration Diagnostics as an effective Tool for Testing Engines of Internal Combustion

Ferenc Dömötör<sup>1</sup>, József Zoltán Szabó<sup>2</sup>

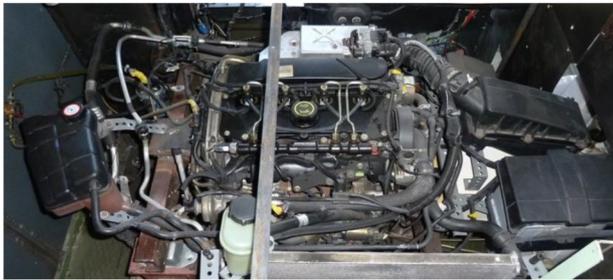
Fig. 1. Layout of the Ford Mondeo Diesel engine

Initially, a Diesel engine of a Ford Mondeo TDCi vehicle was tested (Fig. 1). It has been installed and operated on a block-testing stand of Schönebeck type, i.e. it was not measured while working in a vehicle. Technical data of the engine are shown in Table 1.

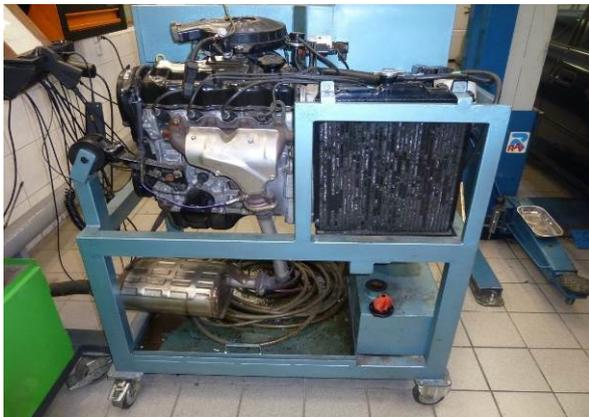
Fig. 2. General layout of the Suzuki Swift 1.3 engine

In the second part of the project two different Suzuki engines were tested. One of them was a Suzuki Swift 1.3 installed on a block-testing stand (Fig.2). Technical data of the engine and the main parameters of the vibration measurements are shown in the first column of Table 2.
