PRODUCTION ENGINEERING ARCHIVES

2016, Vol. 13, No. 4, pp 20-25 ISSN 2353-5156 ISSN 2353-7779

Fractography analysis of Inconel 718 fatigued at 700°C

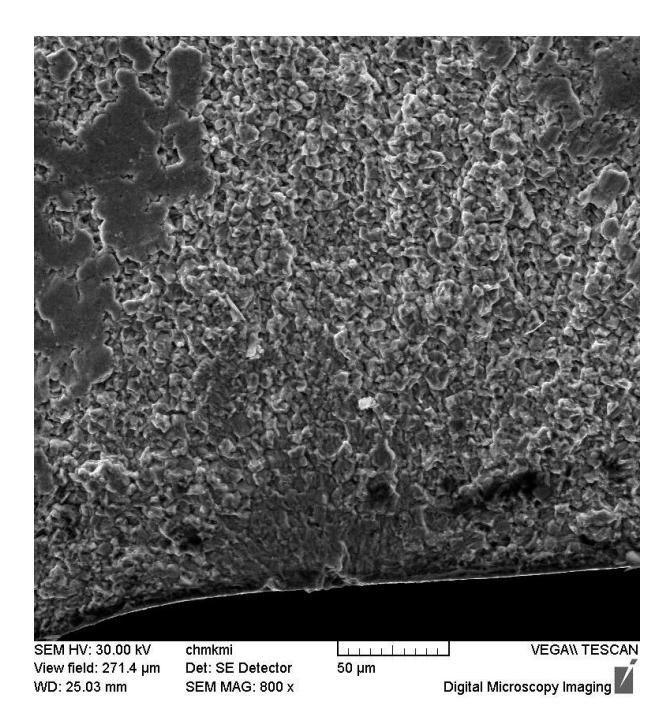
Fig. 1. Typical initiation site, In 718 cyclically loaded at 700°C, REM.

Initiation of the fatigue crack takes place solely on the carbidic or carbonitridic particles at surfaces or subsurface area (Fig. 1 and 2), which is in clear contrast with the crystallographic initiation observed at fracture surfaces of specimens fatigued at ambient temperatures. In the study of (ABIKHI M. ET AL. 2013) was well described mechanism of crack initiation of carbide particles at specimens cyclically loaded at high temperature at small frequencies of loading (oxidation and subsequent volume expansion of carbide particles caused internal stresses in the matrix, which serves as a preferred initiation places). Implementation of this mechanism in the study is questionable, and it needs some more research to confirm or reject this claim, but in general, for example, the specimen broken after $N_f = 3.6 \times 10^6$ cycles, had quite sufficient time to oxidation of carbide particles, because in the high cycle fatigue, initiation stage consume more than 90% of the whole time of the fatigue test and duration of test was 7.5 hours.

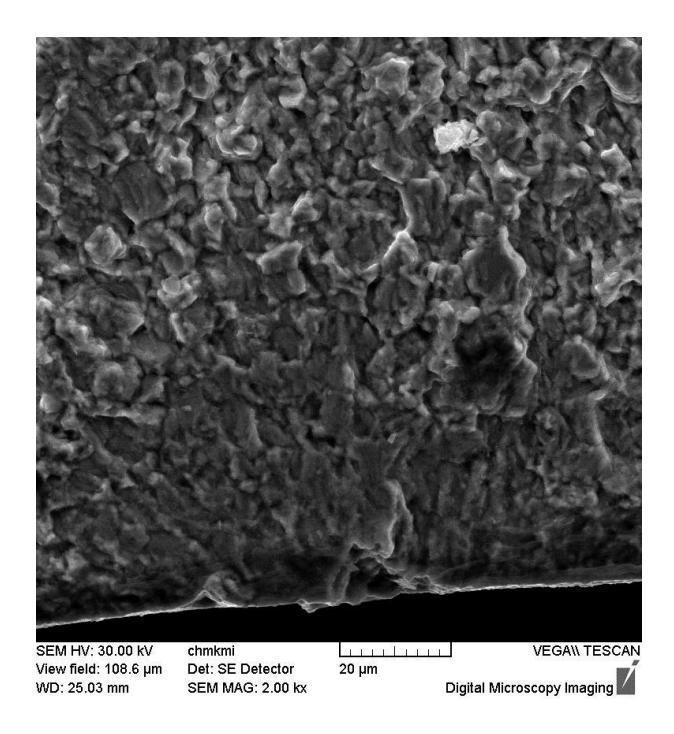
Fig. 2. Detail of the initiation place, there is clearly visible that initiation of fatigue crack took place on the carbonitridic particle, REM.

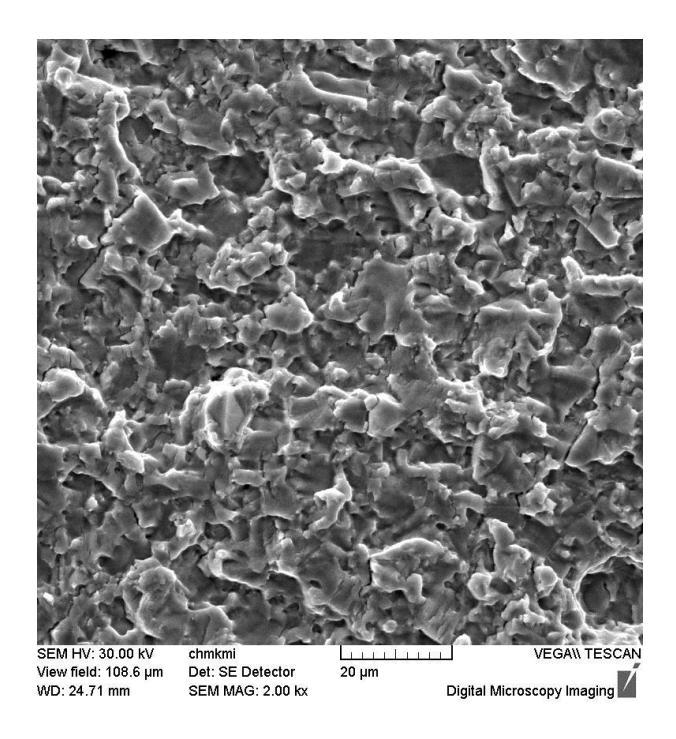
Fig. 3. Area of fatigue crack propagation, there is visible rough character of fracture surface, REM.

Fatigue crack propagation occurs by the transcrystalline ductile mechanism (Fig. 3), while on the fracture surface a great number of the secondary cracks was observed. Facets of intercrystalline fatigue crack propagation weren't observed in neither case. Formation of intercrystalline fracture is in the case of In 718 is conditional on the present the high content of laves phase (which is not possible in the wrought material) or by very high level of oxidation of the grain boundaries region, but this case is possible only when specimens are loaded at very low frequencies. On the fracture surfaces, in the crack propagation area striations could be observed, but they were hard to detect due to a certain degree of oxidation at the surface and a significant roughness topography of the fracture surfaces. Fracture profiles observations, showed, that by increasing length of the crack (and thus K_{α}), the fracture profiles had higher roughness, which is well documented on Fig. 5 and 6.

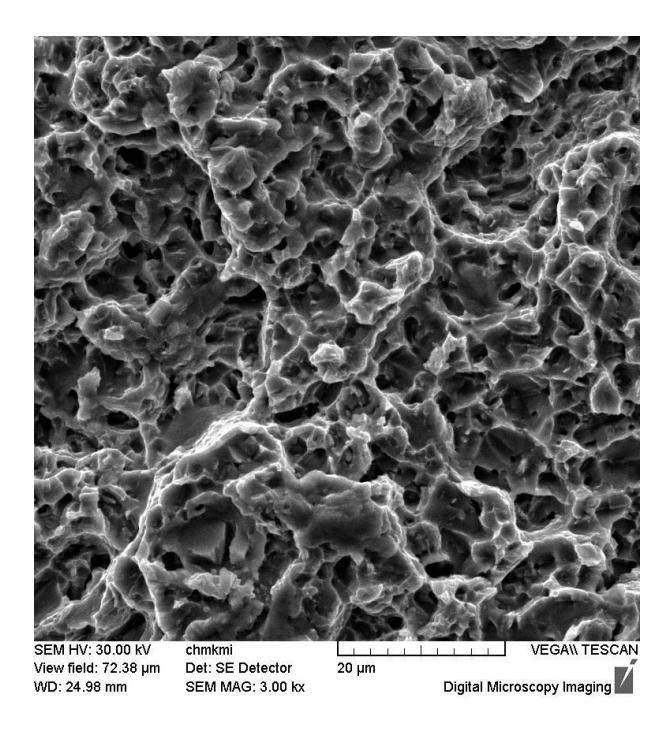
Fig. 4. Final rupture, transcrystalline ductile mechanism with strong dimple morphology, REM.

Final rupture took places by the transcrystalline ductile mechanism with very strong dimple morphology (Fig. 4), which was caused increased ductility in testing temperature. Facets of intercrystalline fracture were not observed in the final rupture region, and it shows a good state of microstructure, even some structural changes caused by cyclic plastic deformation at 700°C, which are described in the next part.

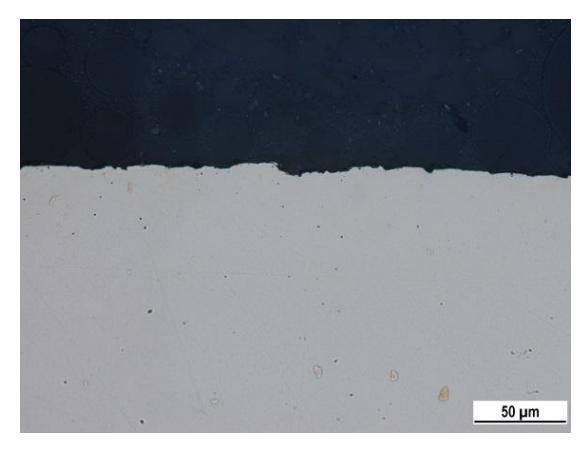
Fig. 5. Crack profile at crack lenght 2.5 mm.

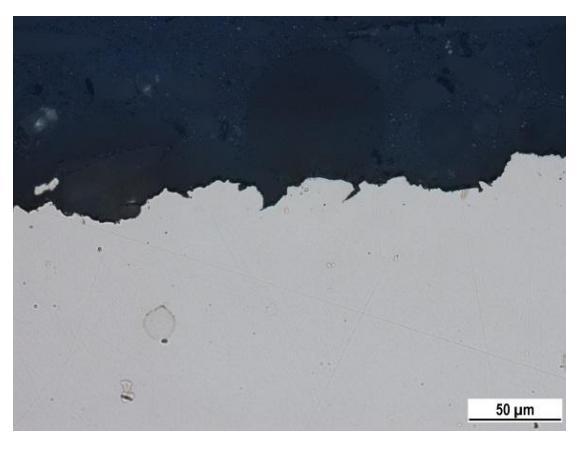
Fig. 6. Crack profile at crack lenght 7.5 mm.

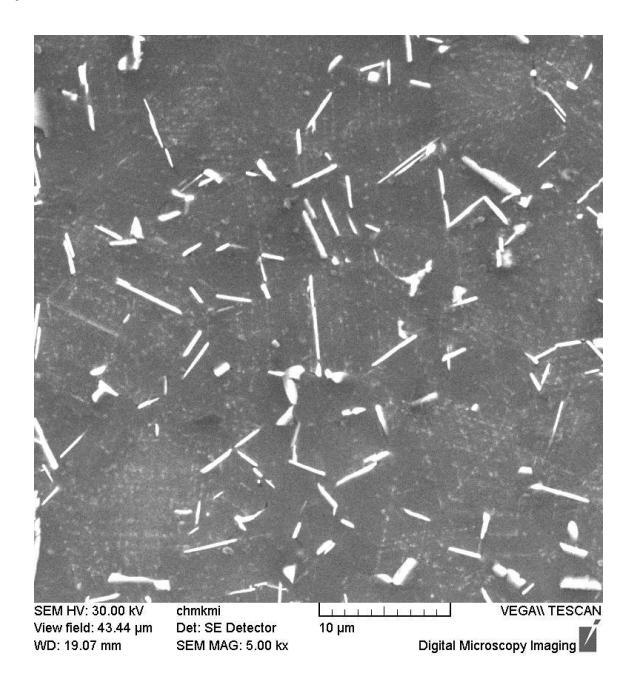
Fig. 7. Microstructure of In 718 of initial state, electrolytically etched in CrO₃ water solution, REM.

Microstructural observation showed that the cyclic plastic deformation at high temperature (700°C) caused significant microstructural changes. Microstructure of the initial state (Fig. 7) consists of the fine grains of gamma matrix, delta phase particles at grain boundaries and with a primary carbides Nb(Ti)C and carbonitridic particles TiNC. In structure there are also fine precipitates gamma prime and gamma double prime, but these are not detectable by this kind of observation due their small dimensions and the strong coherency with the matrix. In the microstructure of the specimen cyclically loaded at 700°C (Fig. 8) were observed significant changes, especially in the form and the amount of the delta phase particles. Cyclic plastic deformation caused mechanical dissolving of gamma double prime particles (this mechanism is described in the work (WORTHEM D.W. ET AL. 1990), which leads to faster transformation of gamma double

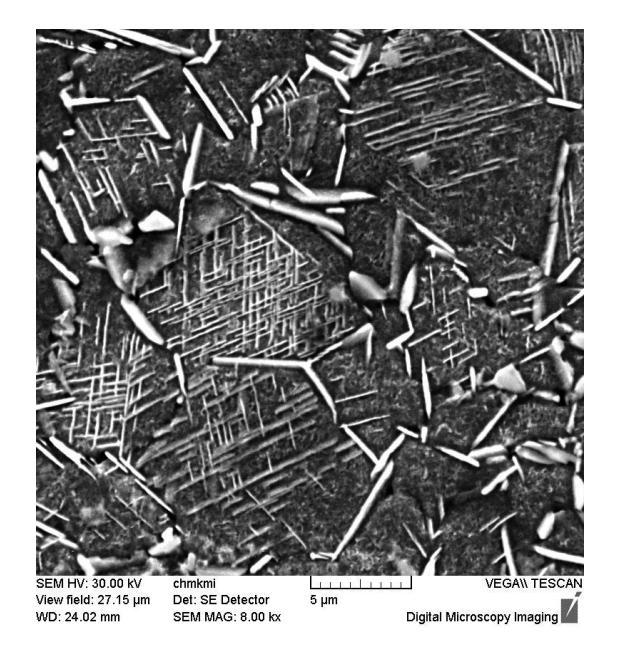
Fig. 8. Microstructure of In 718 after cyclic loading at 700°C, sample from fracture subsurface, great increase of intragranullar delta phase, electrolytically etched in CrO₃ water solution, REM.

prime to the intragranular delta phase (delta precipitate as a plates – in the cross section needles). Despite the fact that the volume of delta phase in the structure dramatically increased, it could be stated that it has no effect of the fatigue process in the Inconel 718 superalloy.
