PRODUCTION ENGINEERING ARCHIVES

Phase Transformations in Nickel base Superalloy Inconel 718 during Cyclic Loading at High Temperature

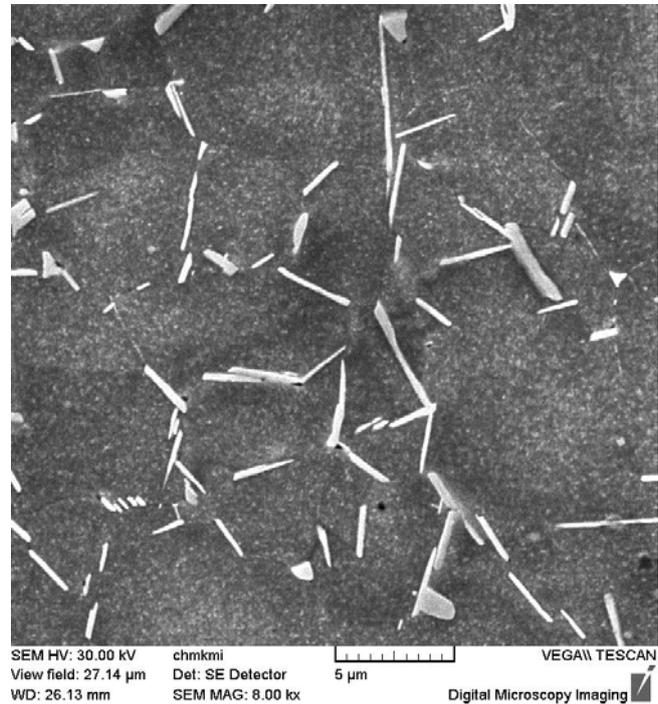
Fig. 1. Microstructure of initial state

Microstructure observation shows significant changes, which took place after cyclic loading at 700°C. Figure 1 and 2 shows the microstructure in initial state and the microstructure after cyclic loading at 700°C, where the duration of loading was 7.5 hours. In microstructure of initial state, particles of the δ phase are localized on the grain boundaries, where, as was stated before, they have positive effect on the properties of the alloy. In microstructure after cyclic loading at 700°C occurred a massive increase of amount of the δ phase particles, which is now present even in the grain interiors. Figure 2 observation shows, that precipitation of the δ phase particles take place on some preferential crystallographic planes. Measurements of microhardness in the areas with increased amount of delta phase shows decrease of values by the 10%. Although there are different, often opposing opinions (RADAVICH J.F. 1989, LIS. ET AL. 1994, RUIZ C. ET AL. 1992) on the influence of the

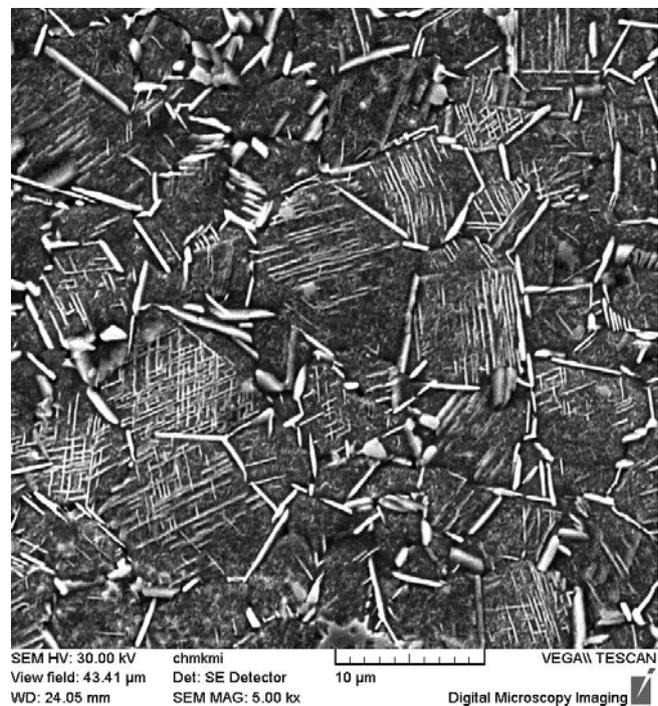
Fig. 2. Microstructure after cyclic loading at 700°C for 7.5 hours

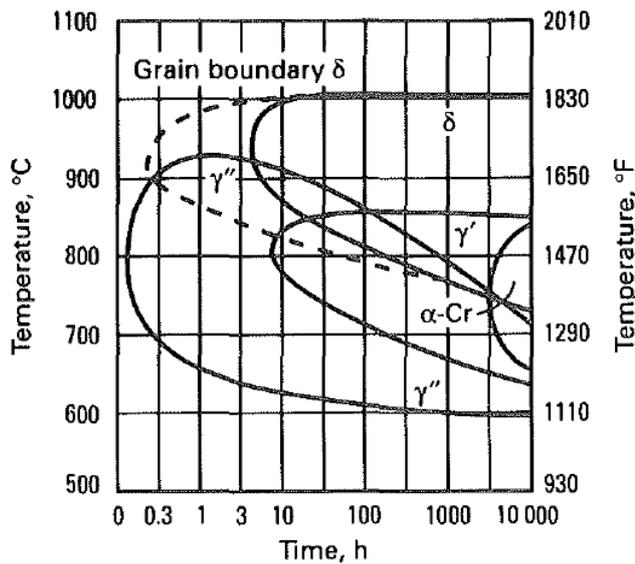
Fig. 2. TTT diagram for In 718

Study of published TTT diagrams of for Inconel 718 (Fig.3) shows, that no significant microstructural changes should take place at exposure to 700°C for such a short time (7.5h). Based on this fact, observed changes must be caused by superposition of other factors, as only a temperature exposure. To understand these changes it is necessary to understand mechanisms of plastic deformation and the interaction of precipitates with the dislocations in the precipitation hardenable materials, like the nickel base superalloy Inconel 718. During cyclic plastic deformation in Inconel 718, in the first stage increase the dislocation density, which causes a slight increase of resonant frequency of the tested specimen. Dislocations are pinning on the precipitates, where the increase of dislocation density causes the increase of the stress required for the further formation and movement of the dislocations. When dislocation interacts with the precipitate, there are known two basic phenomena, depending on the size of the precipitates. The first case, when precipitates are small enough, the dislocation can shear them and the second case, typical for larger precipitates, a so called Orowan looping takes place (HULL B. 2005, PINEAU A. 2009, SIMS S. H. 1987). In Inconel 718, the particles of γ'' has a disc shape, with the diameter of 30-60nm and thickness 5-9nm, so shearing is the preferred interaction of dislocation with the precipitates γ'' . Gamma double prime is an ordered precipitate with the D022 crystal structure and for its shearing are necessary super dislocations with the double Burger's vector, than a regular dislocation in FCC matrix (REED C. 2006). Superdislocations are high energy configuration state, so their formation begins in the second stage of cyclic plastic deformation. At the beginning of the second stage, movement of the free dislocations is exhausted, so any other plastic deformation can be accommodated only by the shearing of the precipitates by super dislocations, whose formation begins as a consequence of increasing critical stress for dislocation movement. This process will show up in the decrease of resonant frequency of the tested specimen. During shearing
